NEW YORK STATE SUPERFUND CONTRACT

PRELIMINARY AGREEMENT
(SITE INVESTIGATION)
REPORT

New Cassel Industrial Area Site
North Hempstead, Nassau County

Site No. 130043

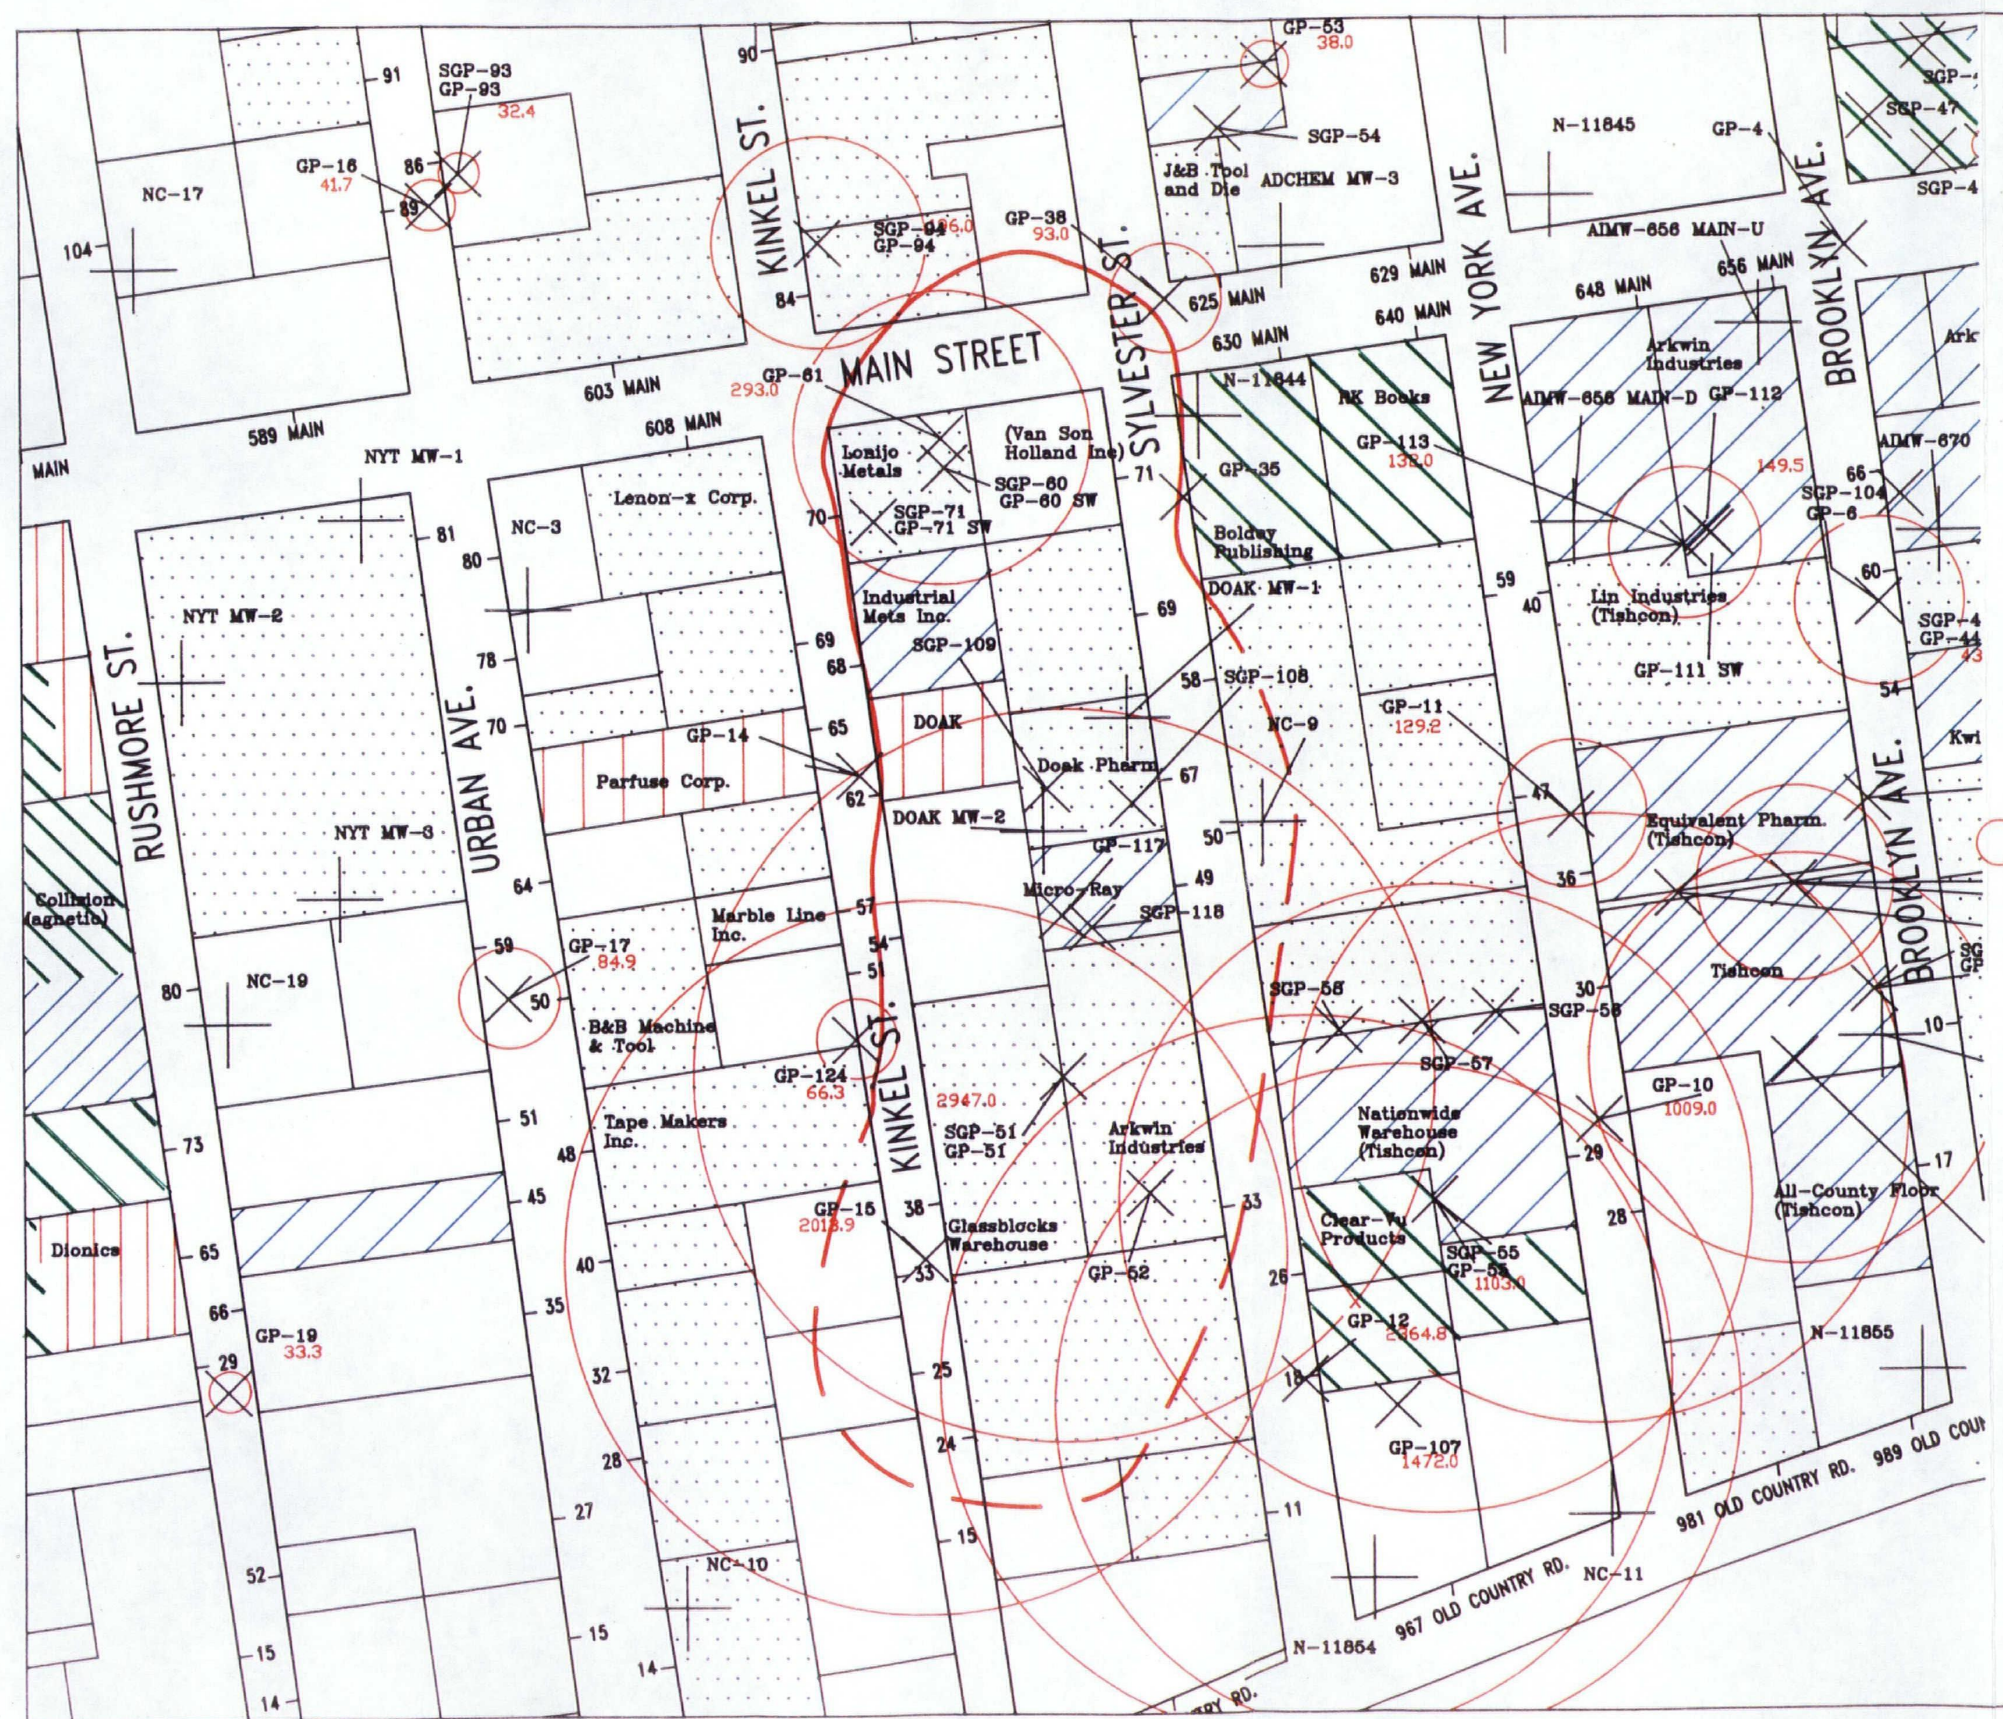
FIGURE 6.19
SYLVESTER/KINKEL ST.
CENTRAL SECTION - NCIA
PCE PLUME
75-85 ft DEPTH
LAWLER, MATUSKY & SKELLY ENGINEERS
Pearl River, New York

Proportional representation of
total detected concentrations
of PCE+TCE+DCE's+VC in
micrograms per liter (ug/l).

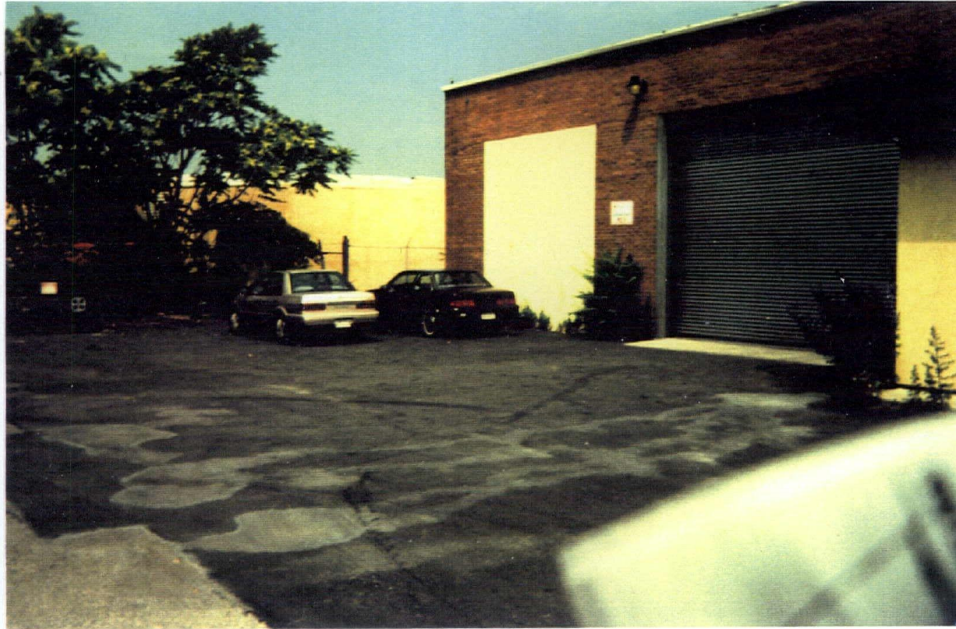
PHOTO 1. Rear of 115 Frost Street (tax block 328, lot 135), occupied by U.S. Polymers.

115 Frost Street. A single-story brick building is occupied by five separate businesses (Appendix B, Photo 1). Except for a landscaping contractor who uses and stores petroleum products to fuel and maintain equipment, all are currently "dry" operations, i.e., use no chemicals. The building, originally constructed as an automobile service center, was reportedly never used for that purpose or used only for a short time. A leach pool or field noted under the pavement south of the building appears to receive roof runoff. GP-33, installed directly

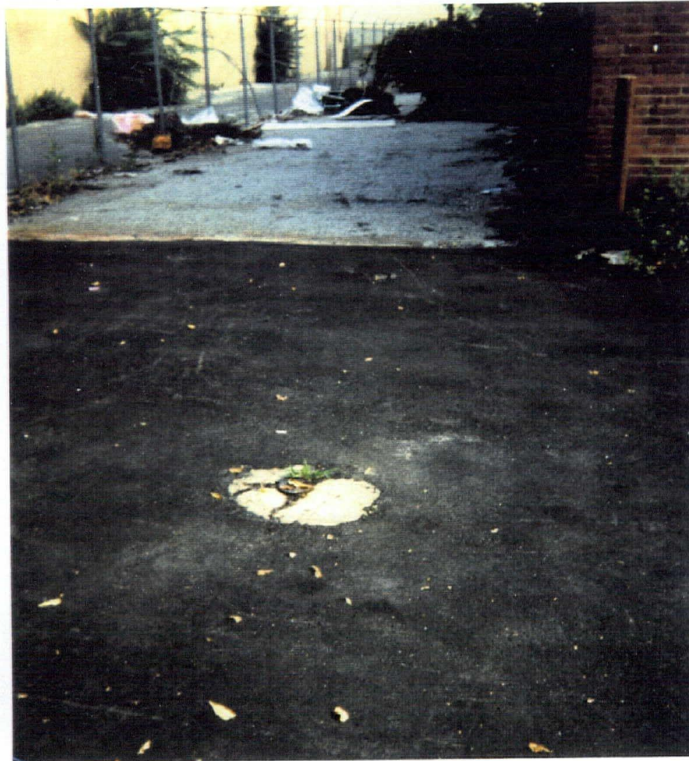
PHOTO 2. Rear of 115 Frost Street, looking north up the alley. Note tank fill port in pavement.

downgradient of this location during the first phase of the Geoprobe investigation, was found to have only trace levels of chlorinated solvents. An UST was also found off the southwest corner of the building (Appendix B, Photo 2). Its capacity is unknown and the tank is empty, although it appears to have contained gasoline or a waste oil/gasoline mix.

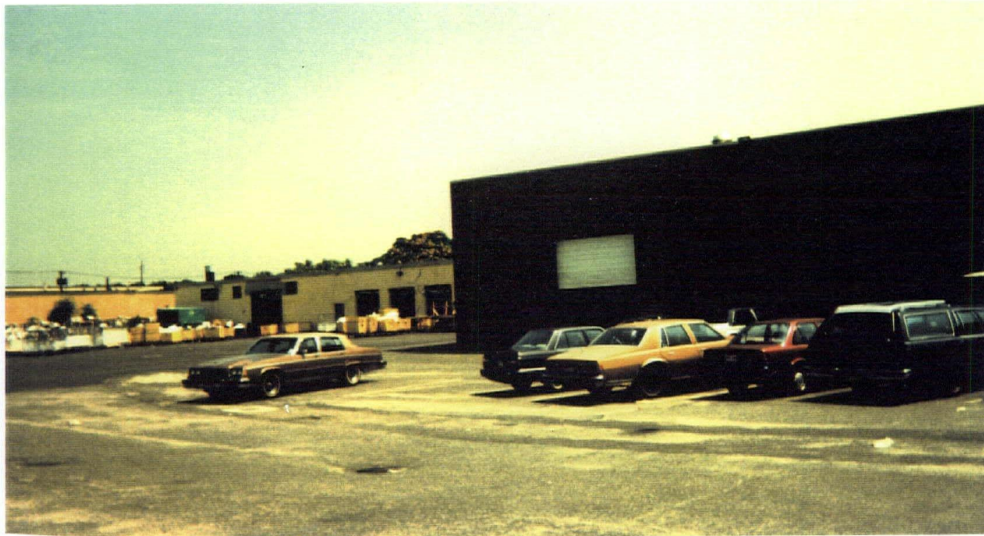
PHOTO 3. Rear of Korg, Inc., at 89 Frost Street (tax block 328, lot 171), looking north at 101 Frost Street.

89 Frost Street. This property is occupied by Korg, Inc., a musical instrument supplier and distributor (Appendix B, Photo 3). Korg has been at its present location for approximately 12 years. The site was formerly a fabric manufacturing company that was destroyed by fire over 12 years ago. Korg does not use or store any chemicals, and no manufacturing is done at the site. A suspected leach pool was found in the alley between Korg and DSA along with a number of stormwater drains to the rear of the Korg building. No floor drains were noted in the Korg facility.

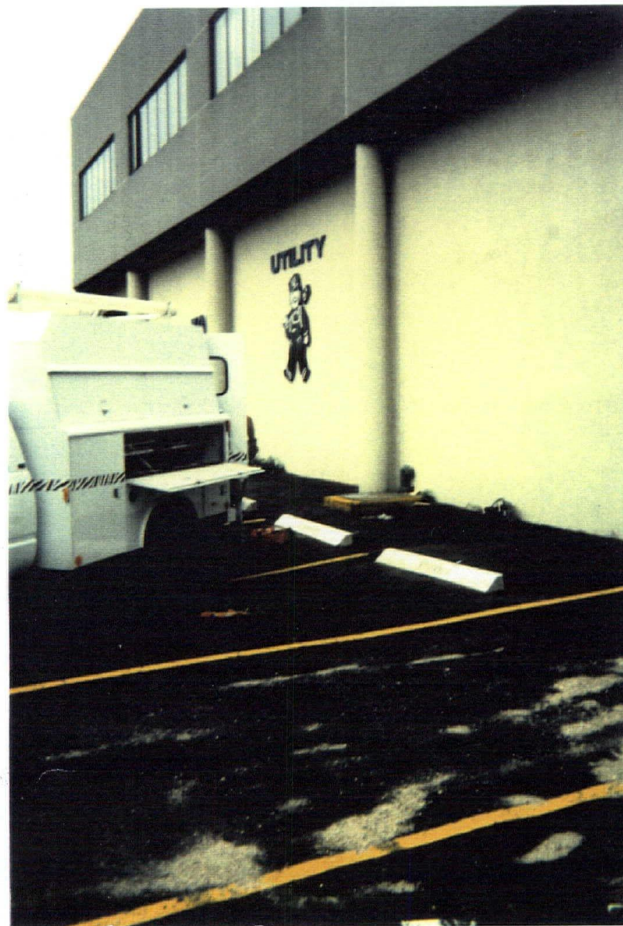
PHOTO 4. Utility Manufacturing at 700 Main Street (tax block 328, lot 176). White truck is Geoprobe rig sampling leachpool.

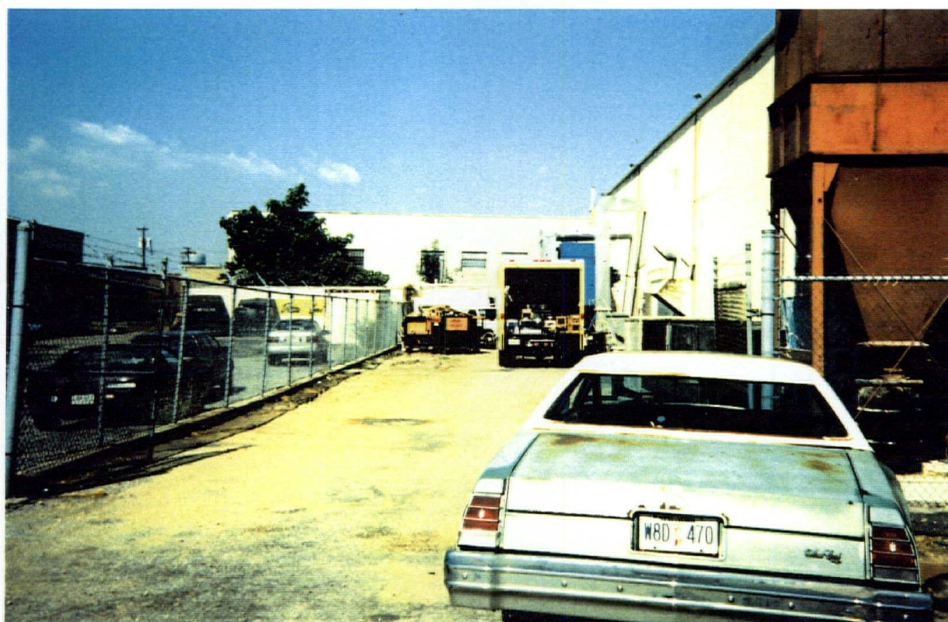
PHOTO 5. Tishcon Corporation at 125 State Street (tax block 181, lot 84), looking west along southern property line. Three leachpools are located approximately 10 ft off chain link fence.

125 State Street. The property at 125 State Street is occupied by Tishcon Corporation, which leases the site (Appendix B, Photos 5 and 6). Most of the property is covered by a brick warehouse-type building in which Tishcon manufactures tablets used as dietary supplements and conducts a tablet-coating operation and warehousing. The Tishcon quality assurance officer reported that three leach pools noted near the southern property boundary had received process waters and the westernmost pool was currently being remediated with county assistance. Soils near the pools were stained by red and orange food coloring and had a strong sewage odor. Based on this information, several sampling locations were selected at 125 State Street.

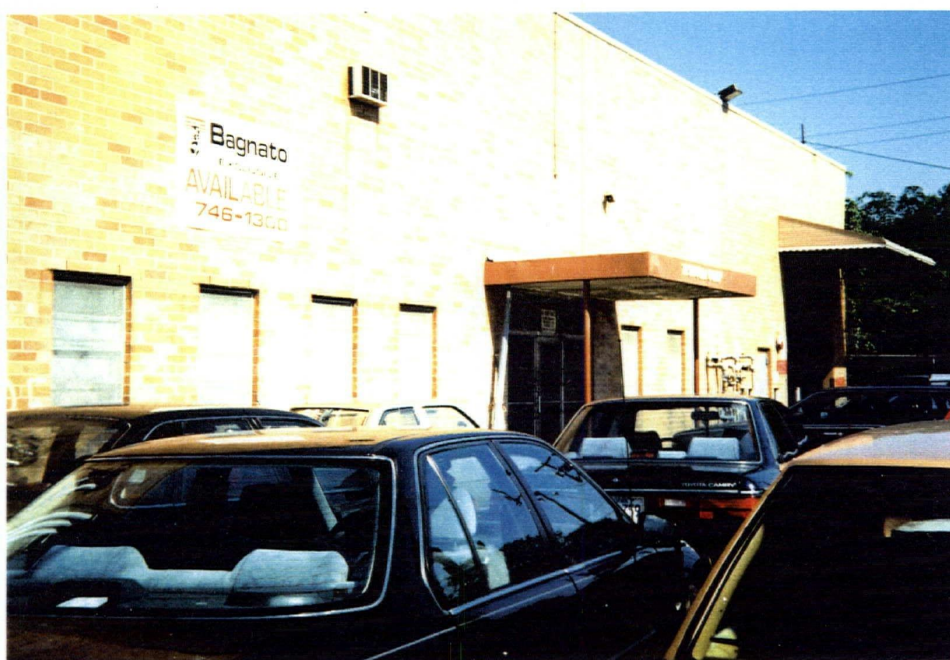
PHOTO 6. Tishcon Corporation at 125 State Street - front of building along State Street.

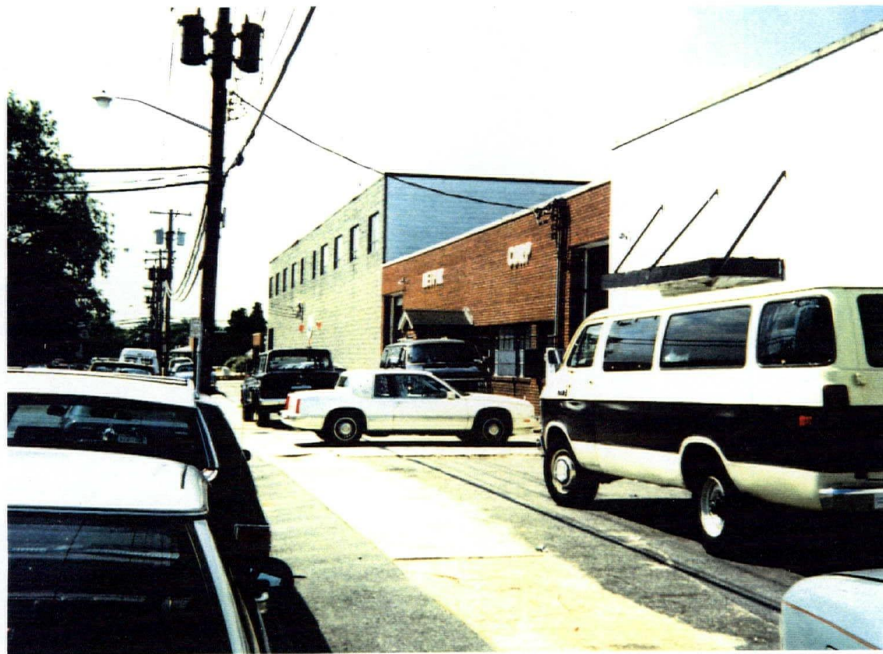
PHOTO 7. Metpar Steel Products at 95, 97-99 State Street (tax block 161, lots 41, 5-8).

95 and 97-99 State Street. Metpar Steel Products occupies this property (Appendix B, Photo 7). Metpar began production at 97 State Street in 1954 and added 99 State Street in 1961 followed by 95 State Street in 1977. The site has been hooked up to the county sewer since 1987. The site includes office space and sales, receiving, production, and shipping facilities. Metpar manufactures steel and formica metal partitions and doors. Production activities include fabrication, woodworking, assembly, finishing, and shipping. No degreasing or metal plating occurs at the site. Large volumes of adhesives, paints, and paint solvents are used as part of the process. Use of 1,1,1-trichlorethane (TCA) as a lubricant/cleaner on one of the machines was discontinued a year ago after three years of use in favor of an environmentally safe compound. There are no active leach pools at the site. Several suspected pools along the front of the building (State Street) were reported to be abandoned septic pools (Appendix B, Photo 8).

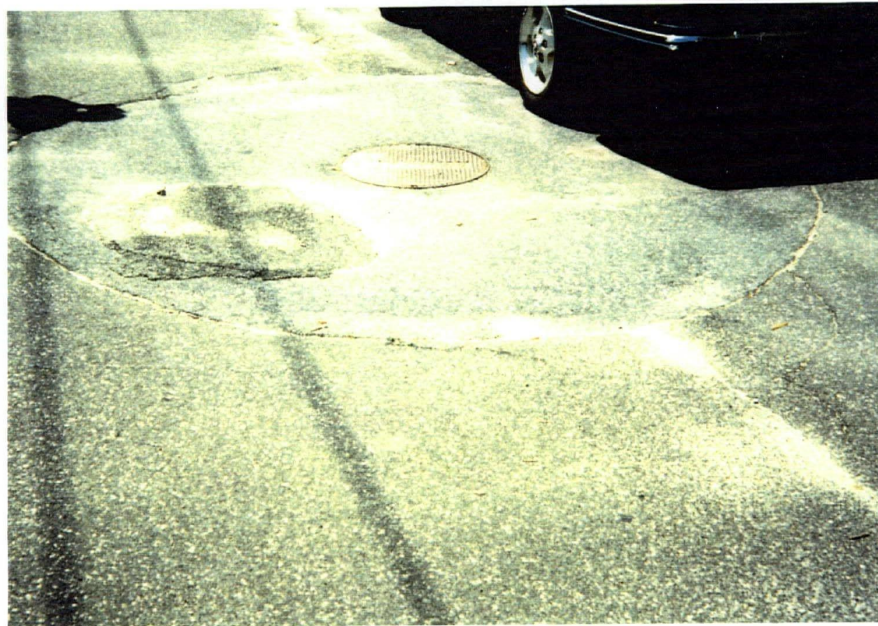
PHOTO 8. Suspected inactive leachpool at 95 State Street.

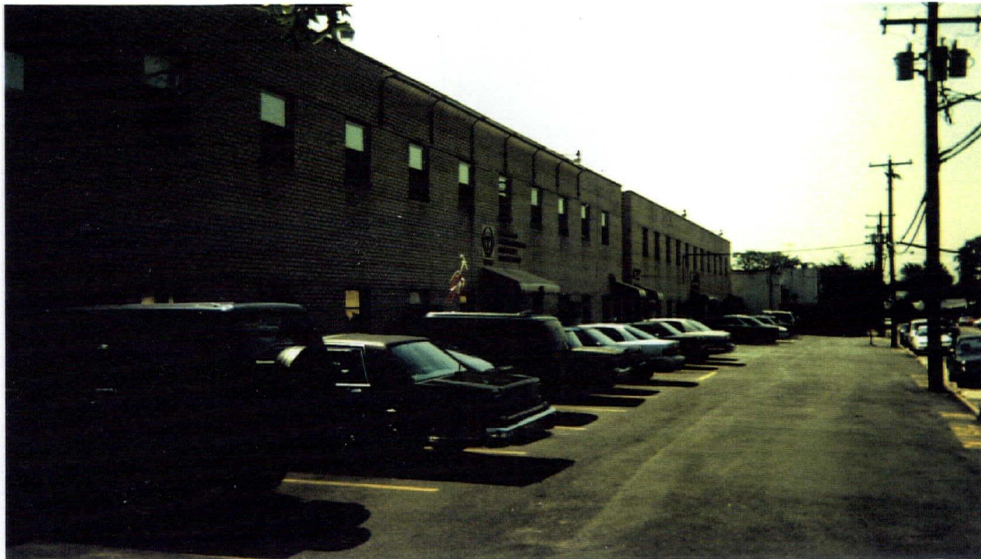
PHOTO 9. Tishcon Corporation at 30 to 36 New York Avenue
(tax block 78, lots 78-79, 19-21, 72-73), looking south.

30 to 36 New York Avenue. These addresses occupy the area between New York Avenue and Brooklyn Avenue (Appendix B, Photo 9). The buildings also have frontage on Brooklyn Avenue (31 and 33 Brooklyn Avenue) (Appendix B, Photo B). The block is currently occupied by several associated business. The largest is Tishcon Corporation, which manufactures dietary supplements such as vitamins. Currently, 30 New York Avenue is used in the manufacture of soft gelatin capsules. One of the final steps in this process is a 1,1,1-TCA dip to remove mineral oil from the capsules. Approximately four drums of TCA are used each week. Spent solvents are reclaimed and the site is a RCRA generator. No floor drains were noted within the buildings. The buildings are attached to the county sewer but formerly discharged wastes to on-site leach pools. No historical building plans are available. The presence of one leach pool (Appendix B, Photos 12, 14, and 17) was confirmed and it is suspected that four to eight additional pools are located on these properties (Appendix B, Photos 11,13,15, and 16).

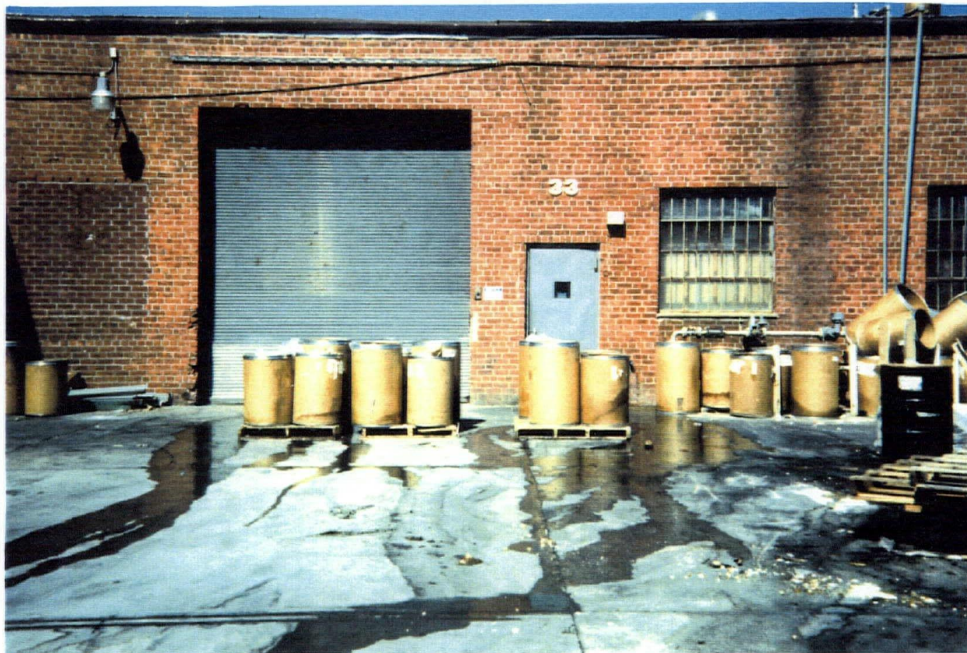
PHOTO 10. Rear of Tishcon Corporation at 33 Brooklyn Avenue
(tax block 78, lot 79), looking west from Brooklyn Avenue.

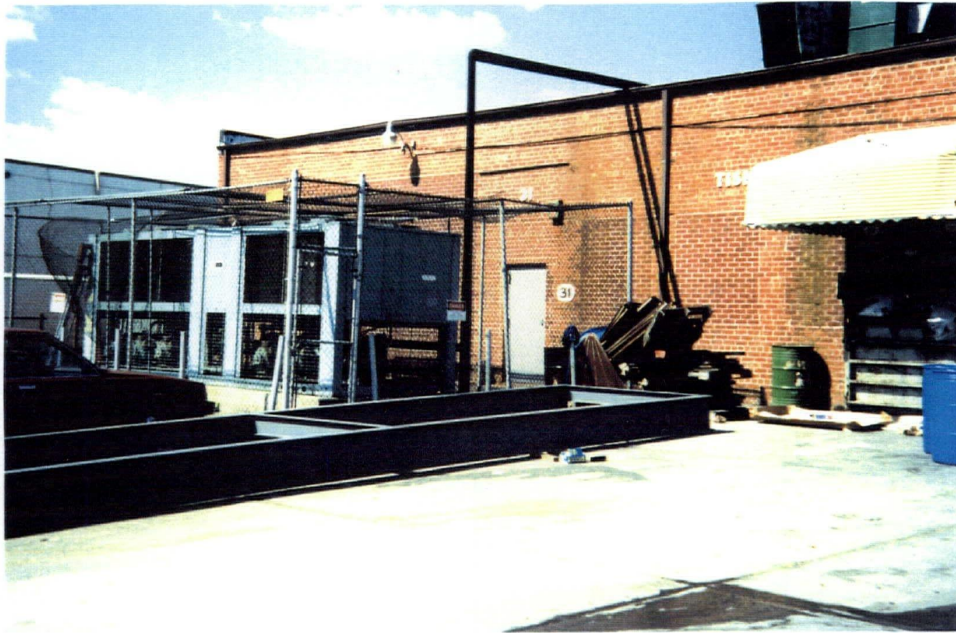
PHOTO 11. Tishcon Corporation at 31 Brooklyn Avenue. Note electrical pad between car and building, which may have been built over a former leachpool.

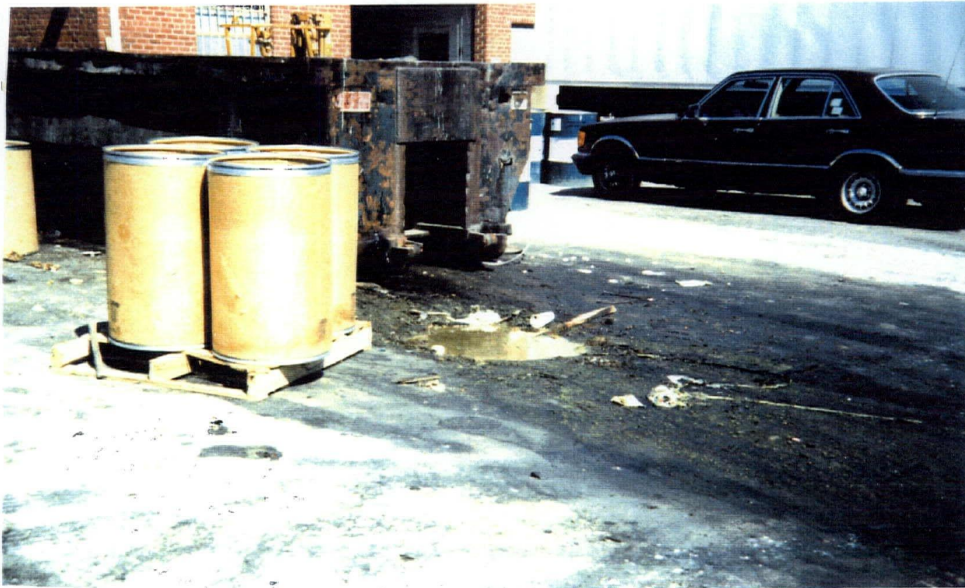
PHOTO 12. Tishcon Corporation at 33 Brooklyn Avenue. Note shallow depression (a former leachpool) in front of dumpster.

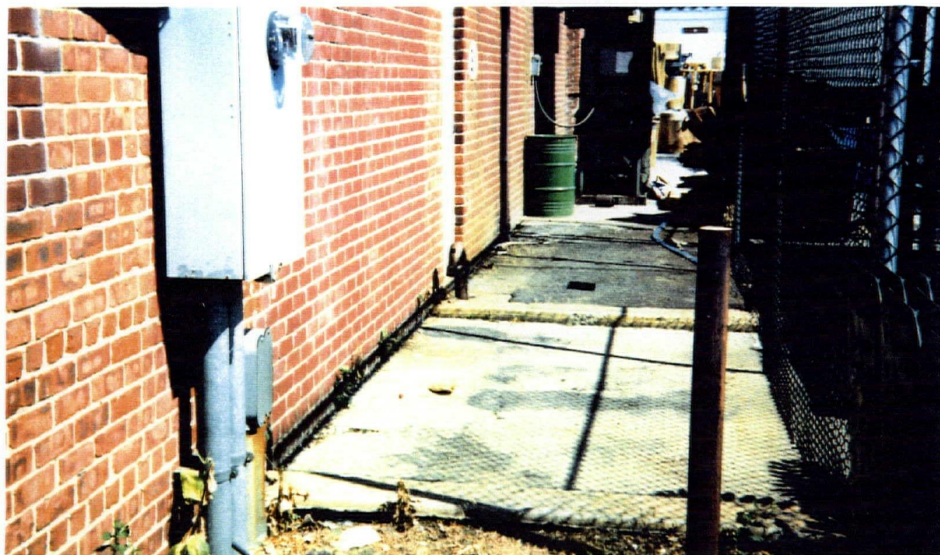
PHOTO 13. Tishcon Corporation at 31 Brooklyn Avenue, looking north. Note sewer vent pipe, which may have led to now-abandoned leachpool.

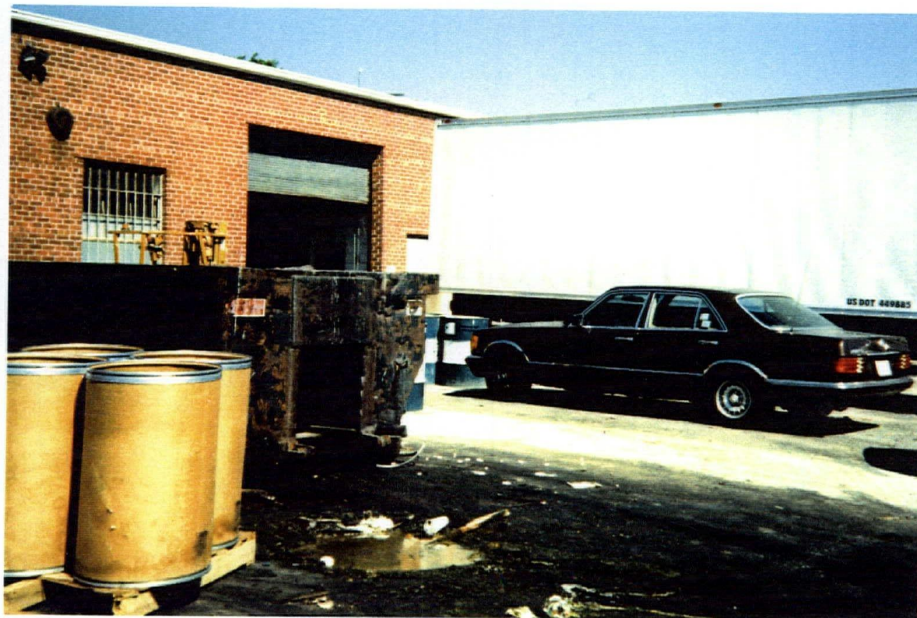
PHOTO 14. Tishcon Corporation at 33 Brooklyn Avenue, looking northwest. Note leachpool near cardboard drums.

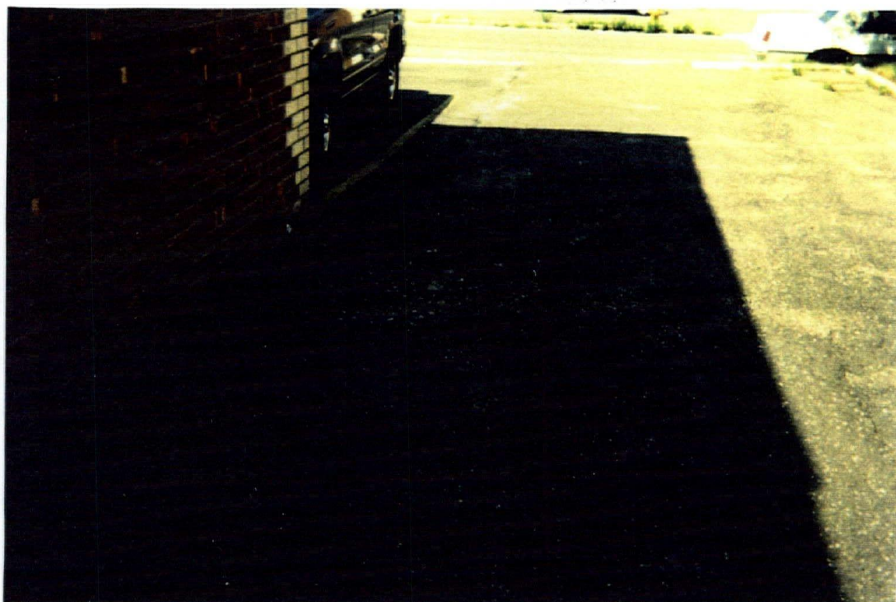
PHOTO 15. Alley along northern property boundary of Tishcon Corporation at 36 New York Avenue, looking west. Note suspected leachpool in center of photo.

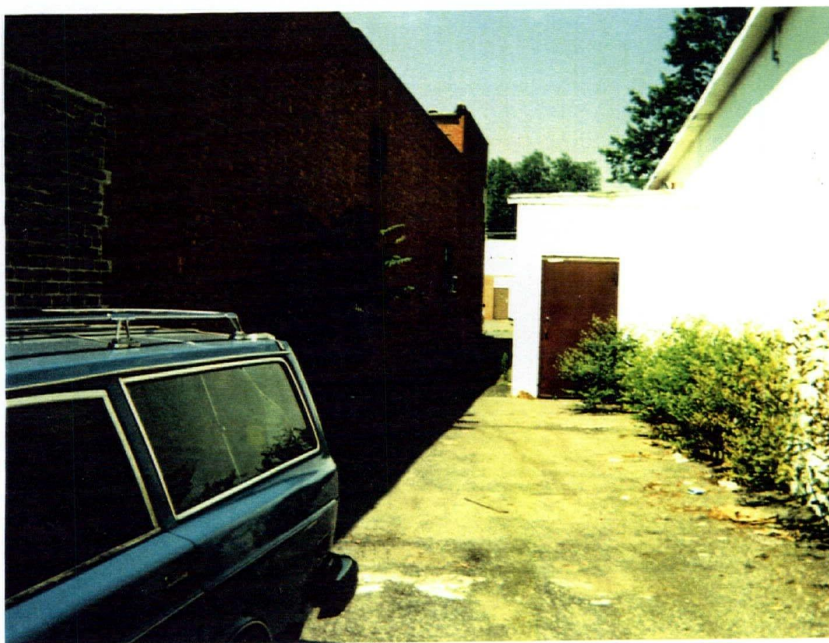
PHOTO 16. Alley along northern property boundary of Tishcon Corporation at 33 Brooklyn Avenue, looking west toward New York Avenue.

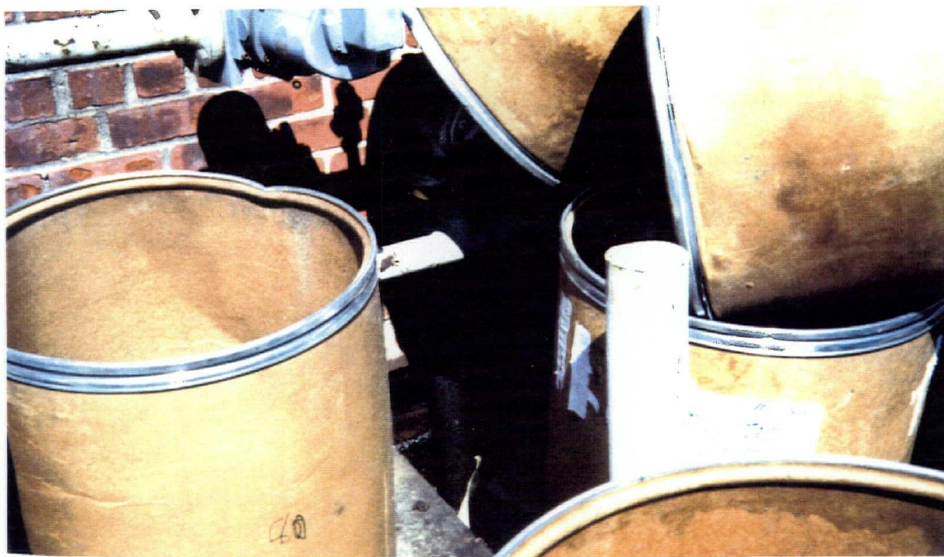
PHOTO 17. Tishcon Corporation at 33 Brooklyn Avenue. Note sewer vent pipe between cardboard drums. This discharge point leads to the now-abandoned leachpool that was contaminated with TCA.

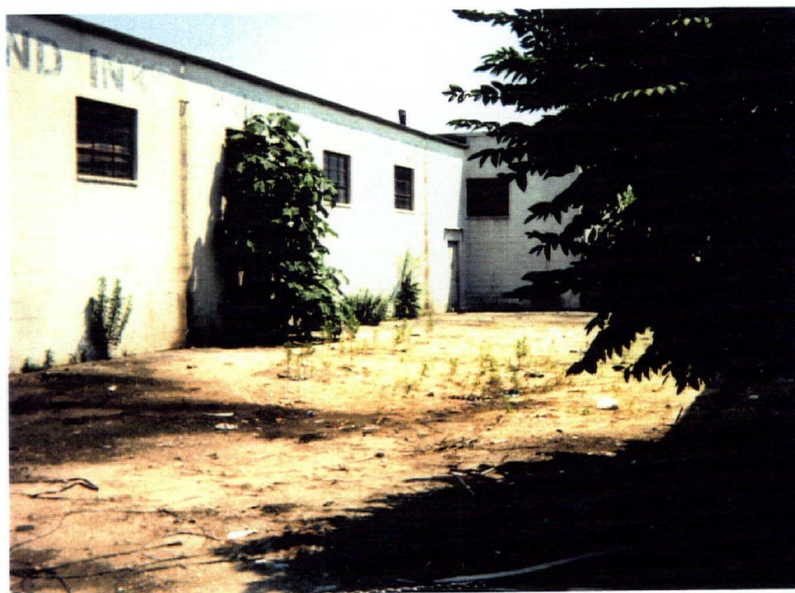
PHOTO 18. Former location of Van Son Holland Ink at Sylvester Street (tax block 76, lots 5-8). Note leachpool in center of photo.

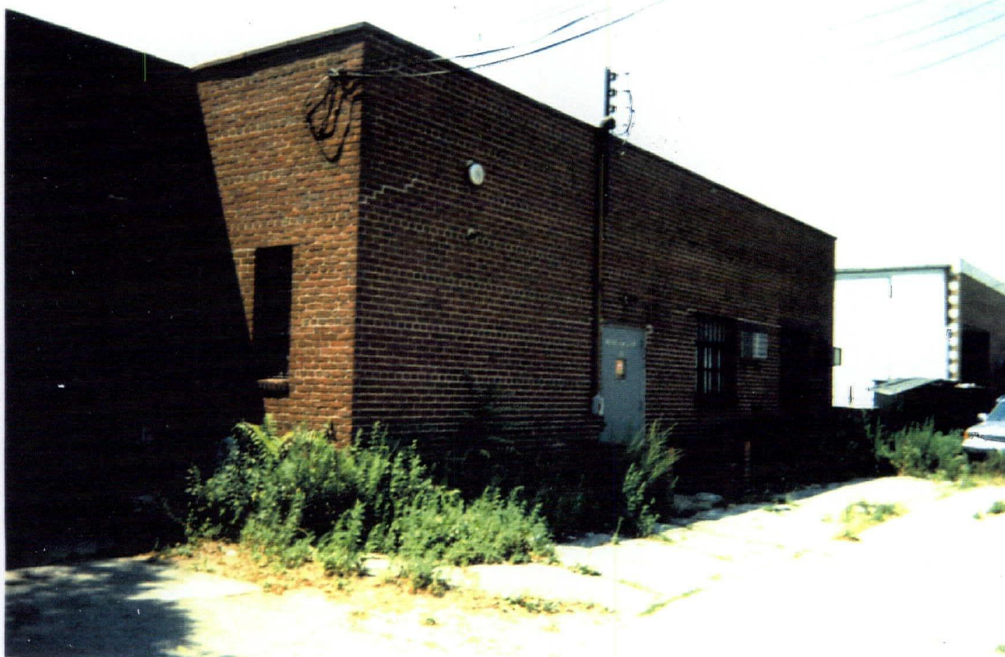
PHOTO 19. Micro-Ray Corporation at 49 Sylvester Street (tax block 76, lots 66-68).

49 Sylvester Street. Micro-Ray Corporation has occupied this address for five years (Appendix B, Photo 19). A manufacturer of small electromechanical parts, its only operation is light machining. The only chemicals used are cutting oils. The space is leased and the company president had no knowledge of past uses or the presence of leach pools. Several leach pools were noted to the rear of the building (Appendix B, Photo 20). Several drum rings were noted on the pavement to the rear of the building. NCDOH records indicate International Ribbon & Carbon, a former occupant, used approximately 500 gal/year of 1,1,1-TCA.

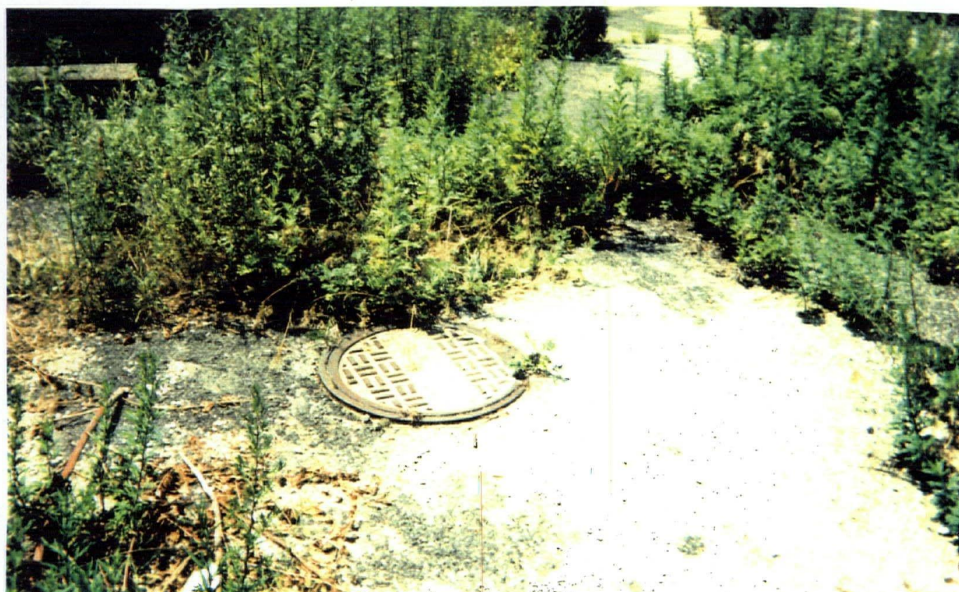
PHOTO 20. Suspected inactive leachpool to the rear of the building at 49 Sylvester Street.

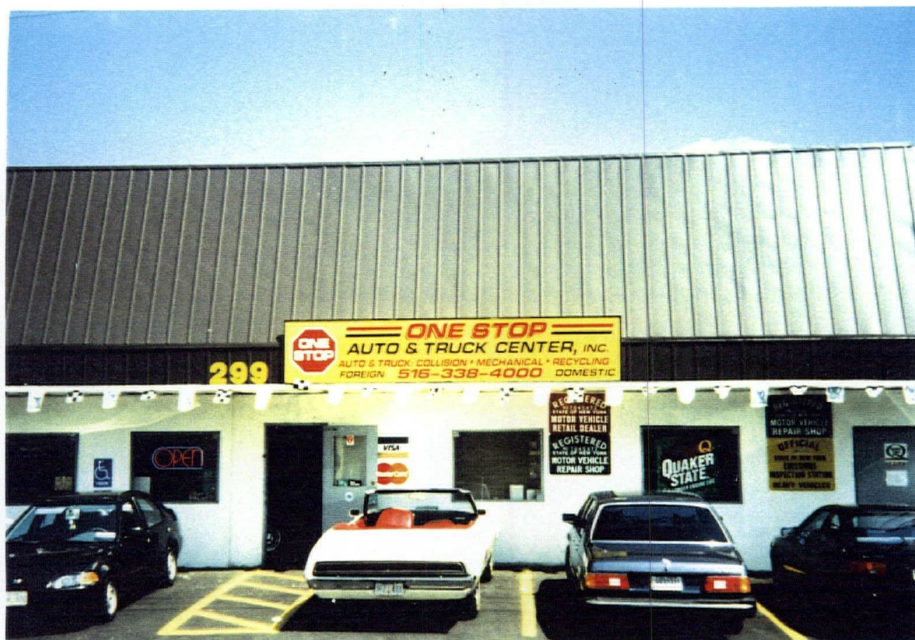
PHOTO 21. One Stop Auto & Truck Center at 299 Main Street (tax block 144, lots 31-50).

299 Main Street. One Stop Auto and Truck Centers has occupied this address since April 1994 (Appendix B, Photos 21 and 22). A full-service auto and truck garage, the firm currently has no underground storage. There were no floor drains within the garage, although there was a grated drain along the garage doors. Where this drain discharges is unknown as the rear lot has been recently paved, covering over signs of old leach pools (Appendix B, Photo 23). The site was formerly a junkyard (Sam-Ton Salvage) for approximately 20 years. Several features at the site suggest that there once was underground storage at the site (Appendix B, Photo 24). Heavy BTEX contamination was noted in a soil sample just above the water table in GP-22 located near this address. NCDOH records indicate Island Transport formerly occupied the site and reportedly used 80 gal/year of trichloroethylene (TCE).

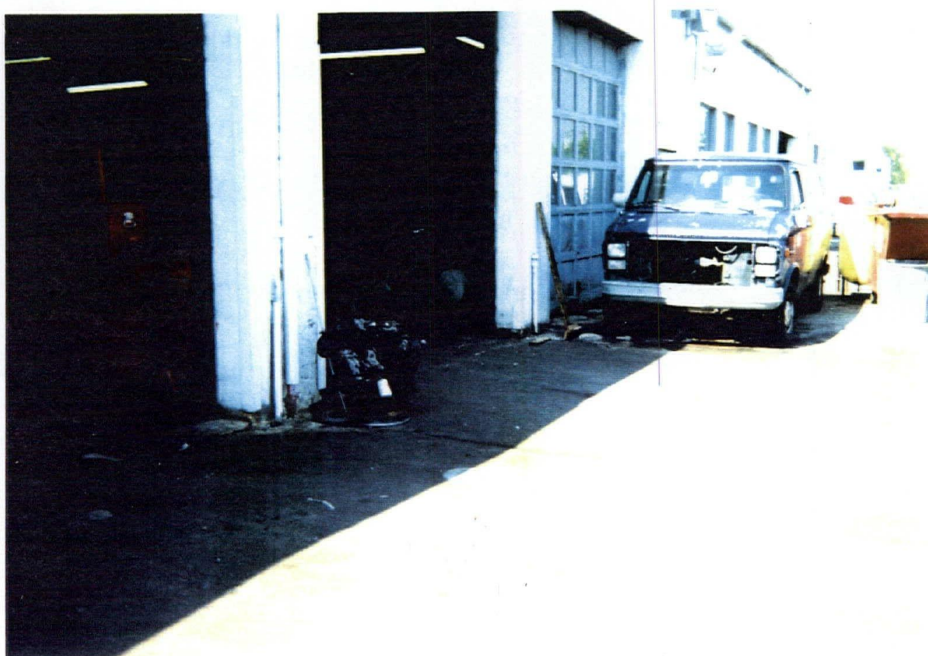
PHOTO 22. Rear of the building at 299 Main Street.

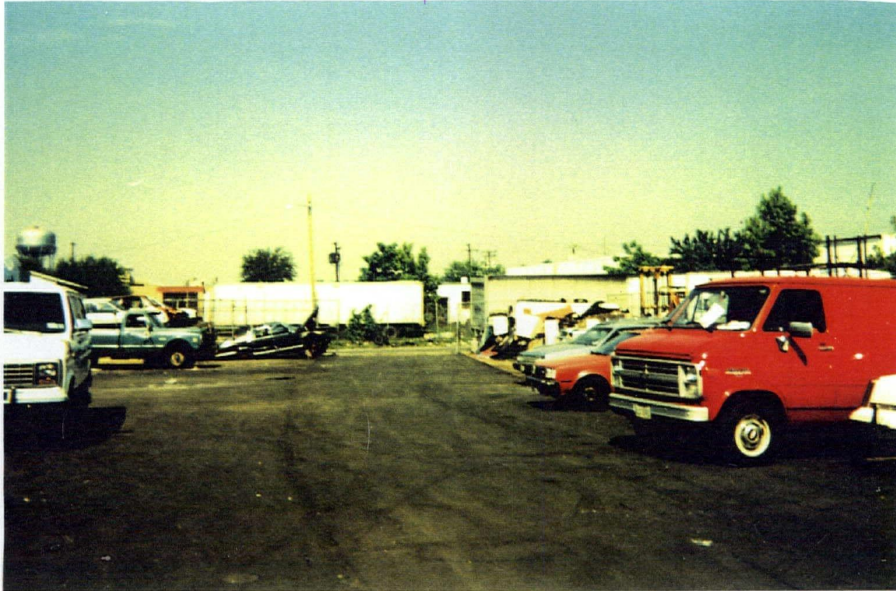
PHOTO 23. One Stop Auto & Truck Center at 299 Main Street.
View is from rear of building, looking west.

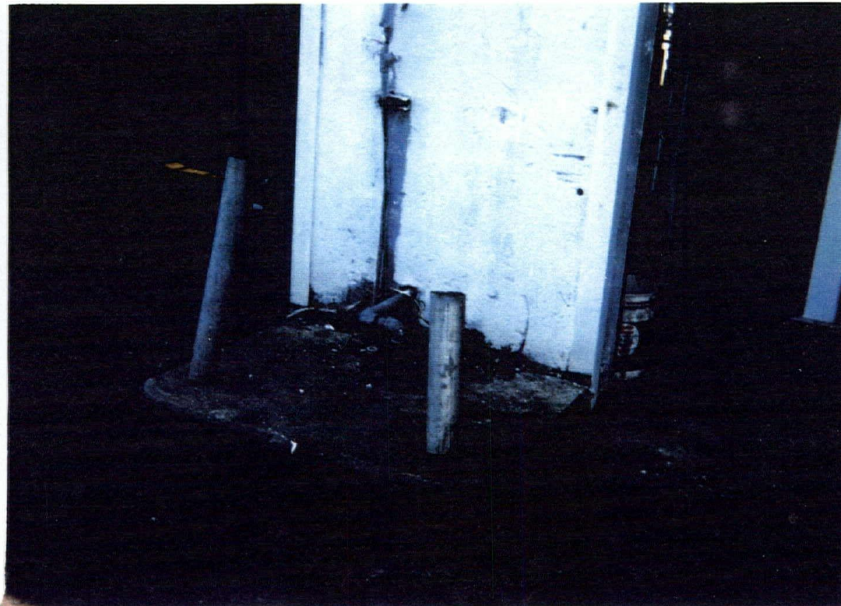
PHOTO 24. Rear of One Stop Auto & Truck Center at 299 Main Street. Note suspected former gasoline pump island.

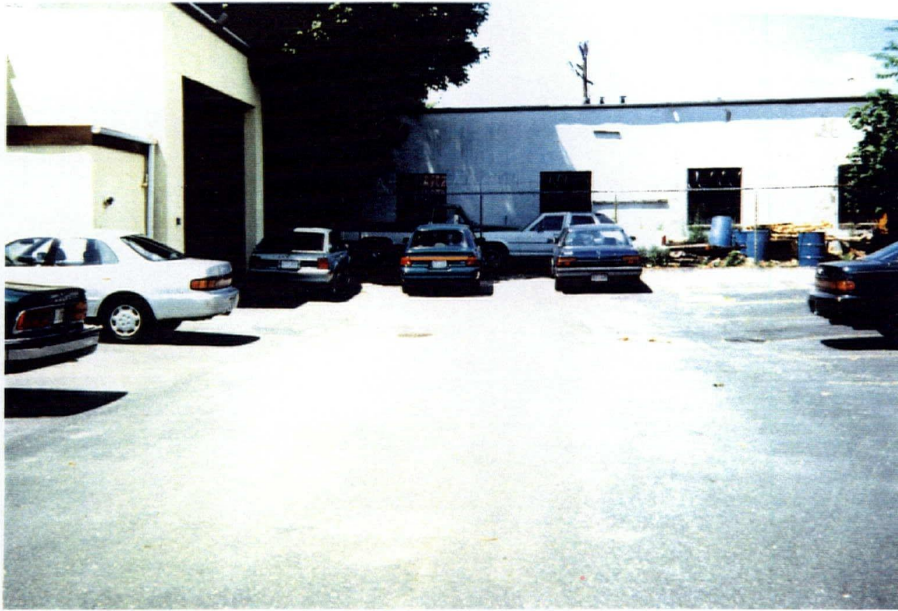
PHOTO 25. 75 Garden Street (tax block 71, lots 5-8). Note storm drains and leachpools in parking lot. 80-86 Magnolia Avenue is in foreground.

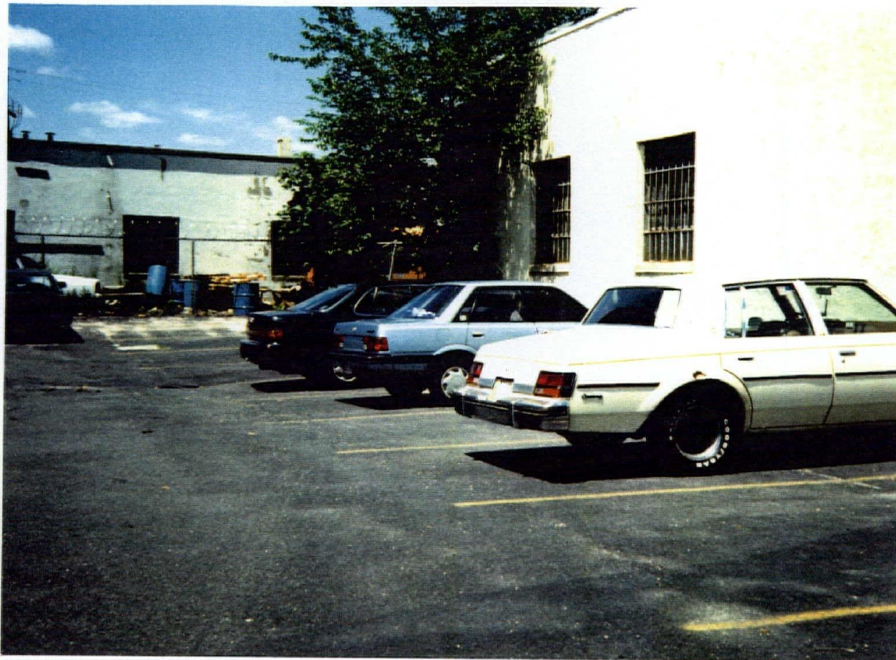
PHOTO 26. 75 Garden Street. Note storm drain in parking lot. Building in right portion of photo is 81 Garden Street.

75 Garden Street. Island Poly Bag and Supply occupies this address (Appendix B, Photos 25 and 26). The property is adjacent and attached to Poly Bag's main office at 514 Grand Boulevard. No manufacturing is conducted on the property; the company is strictly a warehouser and distributor of plastic and paper goods. Originally they operated solely out of 514 Grand Boulevard; 75 Garden Street was purchased and added to the operation in the early 1980s. The owner was unsure of past uses of the property, but believed some type of machine repair was conducted at 75 Garden Street. He also mentioned that several tanks were closed and removed when 75 Garden Street was purchased. The property was hooked up to the county sewer in 1986 or 1987. Locations of the old leach pools could not be determined. Two leach pools and a stormwater drain found in the parking lot on the north half of 75 Garden Street were opened and inspected and found to be of recent construction with a dry, clean, sand bottom. It is believed they never received discharges from within the building and were installed to handle runoff from the roof and parking lot.

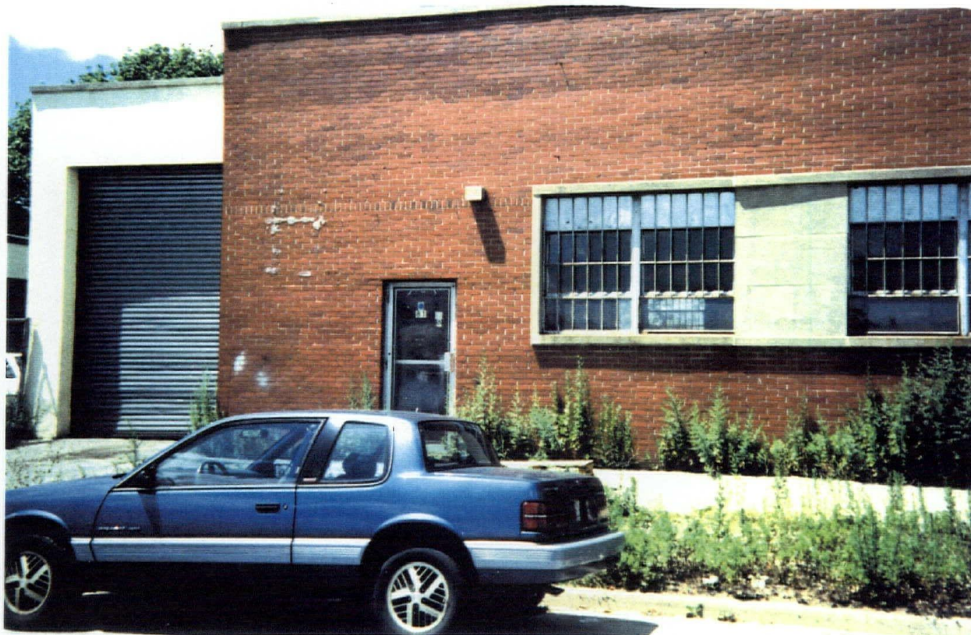
PHOTO 27. Unidentified warehouse at 81 Garden Street (tax block 70, lots 40-42).

81 Garden Street. The property at 81 Garden Street was inspected visually from the outside (Appendix B, Photo 27). Attempts to inspect the interior failed as the building is not occupied during the day. The property appears to be some type of warehouse for storage and is visited infrequently. The building directly abuts the southern property boundary; alleys are located

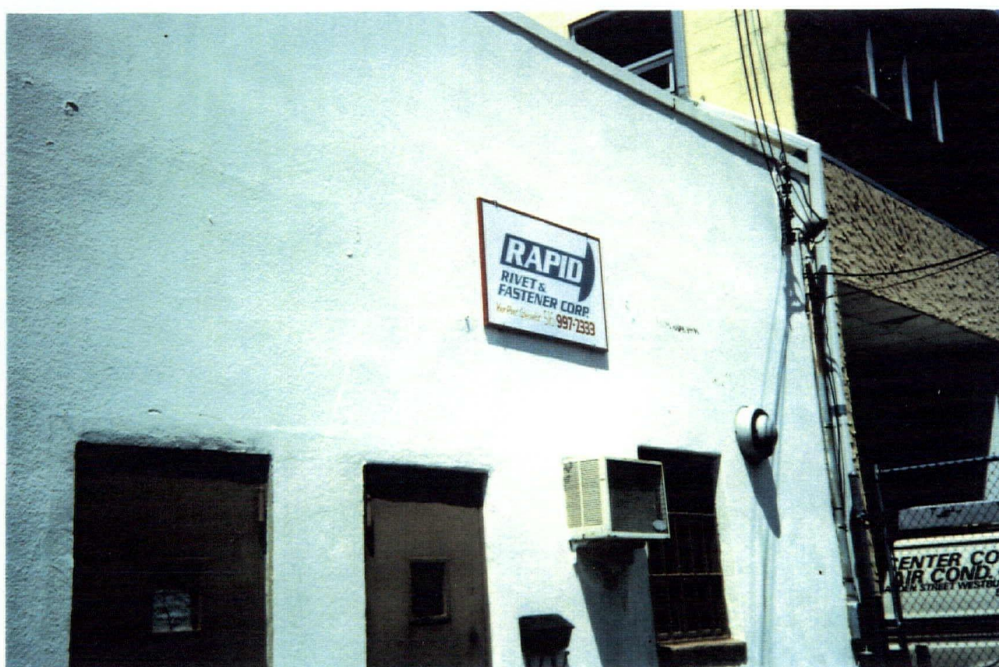
PHOTO 28. Rapid Rivet and Fastener Corporation at 87-89 Garden Street (tax block 70, lots 43-44).

87-89 Garden Street. Rapid Rivet and Fastener Corporation has been on-site for seven years (Appendix B, Photo 28). The company, which ships and distributes specialty rivets and fasteners, is a dry operation and does not use or store any chemicals. The space is leased and information on past uses and disposal histories is limited. A single floor drain noted inside the building was reportedly installed to accept storm water that occasionally seeps into the building. Other than toward the front or inside the building, there are no areas where a leach pool could be located. The building covers most of the lot and there are no alleys.
